Comprehensive Management Plan

Mill Branch Park

Goshen, AR

**Prepared for the City of Goshen
Washington County, Arkansas
By Beaver Watershed Alliance**

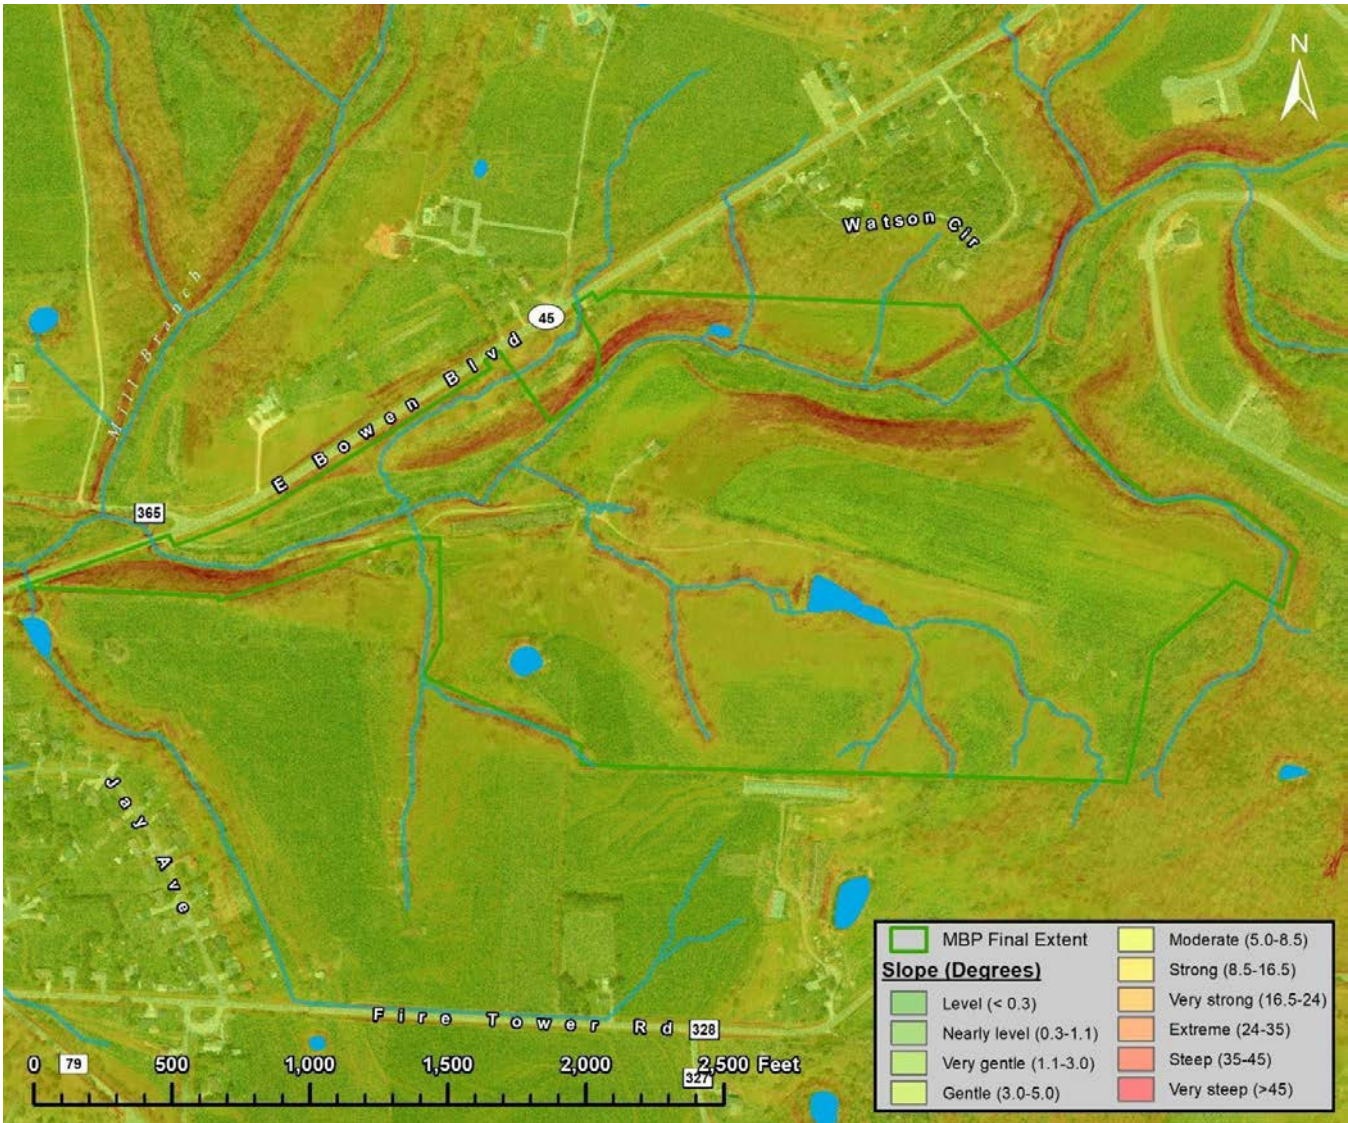
Figure 14: Slope map of Mill Branch Park. Slopes greater than 10 degrees are considered undesirable for casual walking, and all paths should ascend slopes at an angle to avoid gully formation.

majority of Mill Branch Park's slopes are walkable, with 50.5% of the site's slopes being less than 8.5 degrees and 44.7% of the site having slopes between 8.5 and 24 degrees (Fig. 14). Only 4.7% of the site has slopes greater than 24 degrees, these being primarily between the southern access road off E. Bowen Blvd. and the main stream flowing through the property, the northern section of the park between the stream and E. Bowen Blvd., the ridgeline between the stream and the east-central pasture, around the drainages in the southern half of Mill Branch Park, and below the path above the drainage separating Mill Branch Park from The Knolls subdivision.

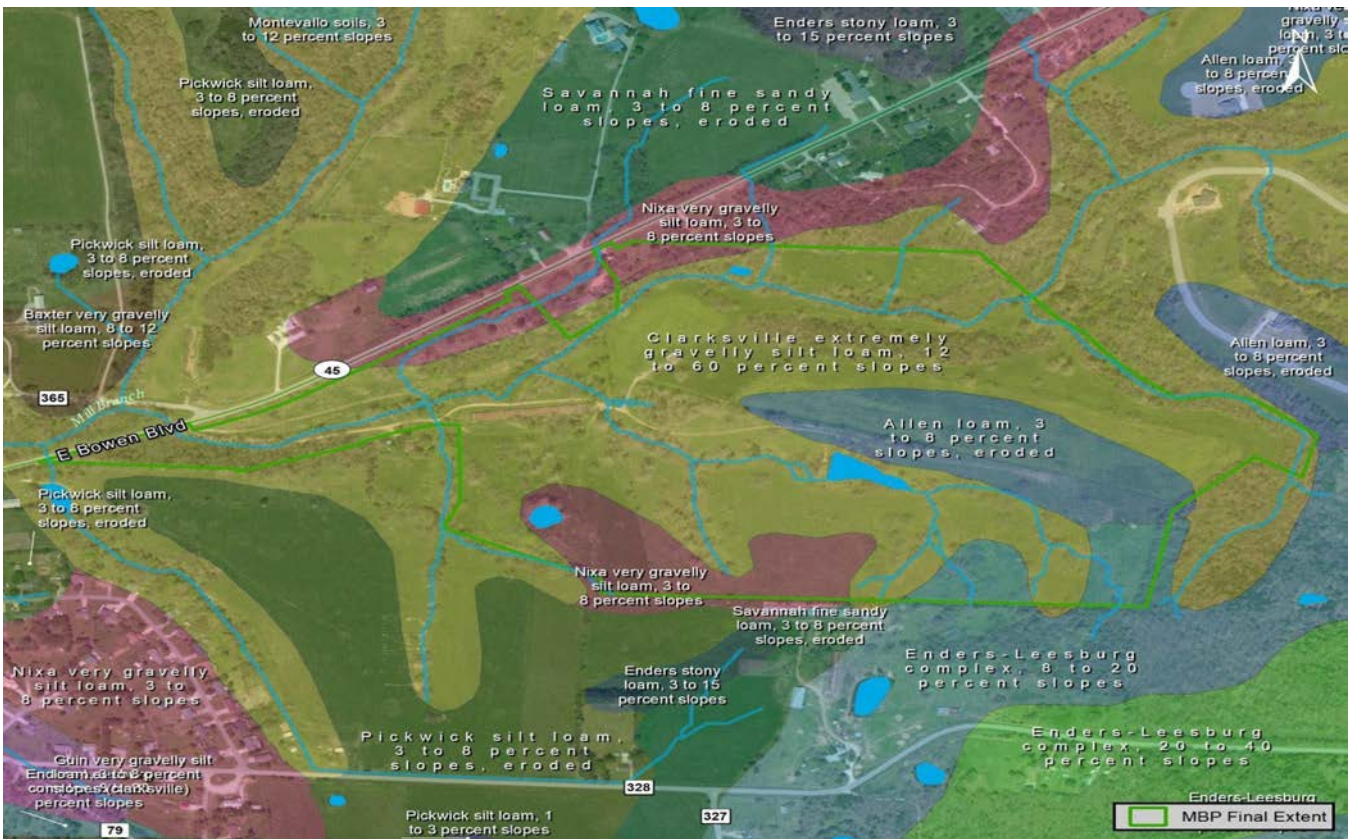
Figure 16: Soil features of Mill Branch Park. Gravelly soils (red and yellow) are very permeable, tending to be great at filtering stormwater and recharging groundwater but also prone to drying out quickly and favoring drought-tolerant plant species. More fertile silt-loam soils (blue, green) tend to recharge groundwater more slowly but also support more vegetation due to their sponge-like ability to hold moisture.

The soils of Mill Branch Park are largely gravel-heavy but fertile, soils deposited from millennia of weathering. The upper slopes show less weathering and retain much more organic material (Fig. 16). The potential for prairie restoration is significant here, but the two soil types have different moisture regimes. Gravelly soils tend to be very porous, with nutrient-rich and water-holding organic matter wedged between the small stones; their water tables tend to be lower as they

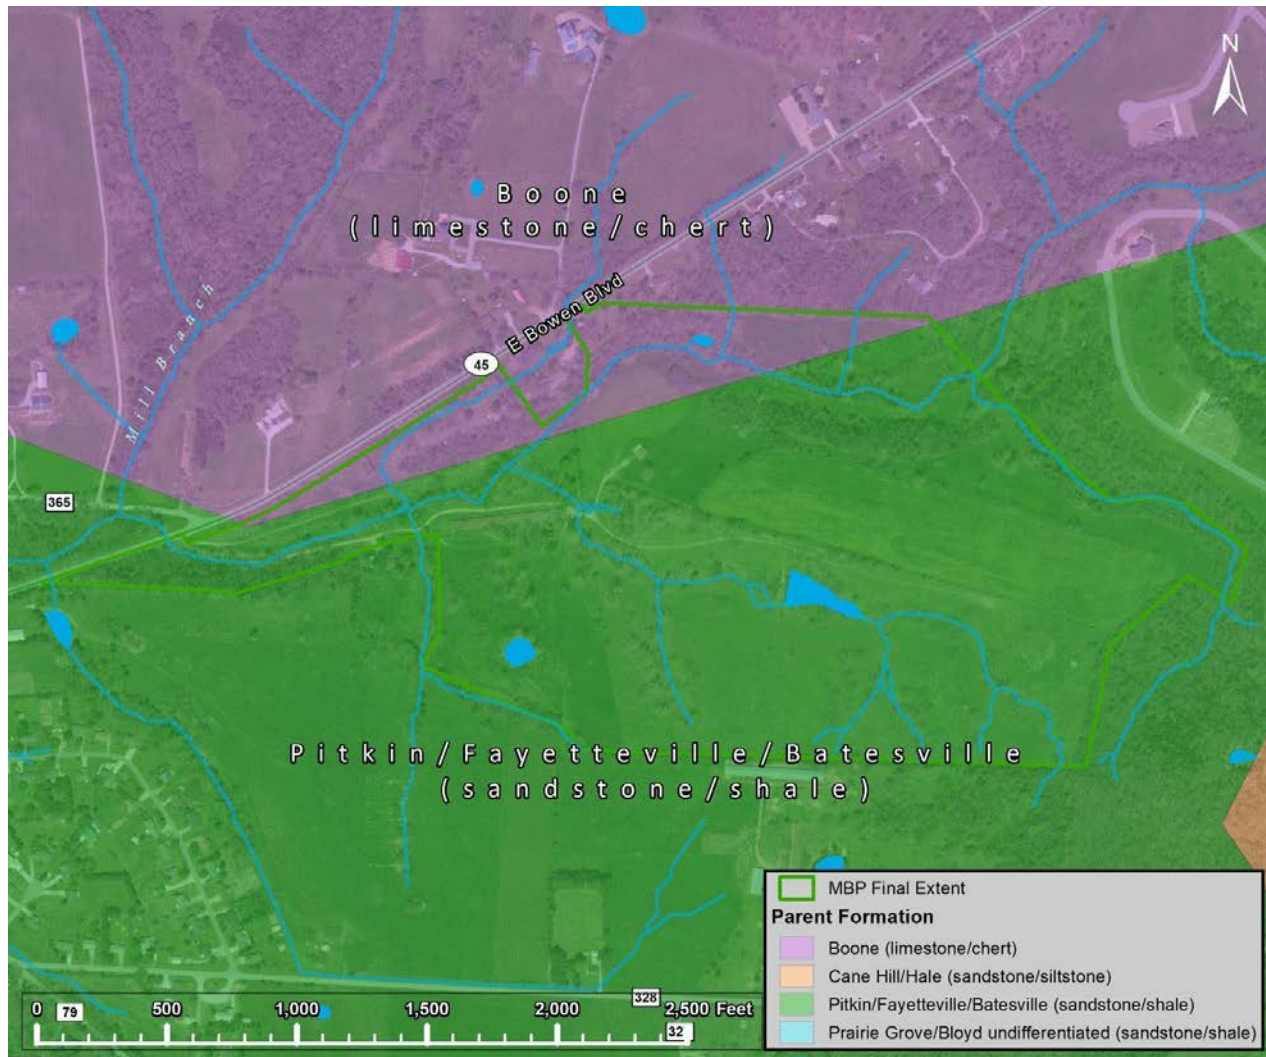
Figure 17: Geological formations of Mill Branch Park. Limestone/chert tend to yield higher pH than sandstone/shale, with plant communities reflecting that difference.

The parent materials of Mill Branch Park are sedimentary limestone, chert, sandstone, and shale formations created during the early-to-middle Mississippian geologic periods (Fig. 17). The NW edge of Mill Branch Park is defined by the Boone Limestone formation, a limestone/chert mix formed during the Meramecian (335-340 MYA) and Osagean (345-350 MYA) geologic periods. The southern portion of Mill Branch Park is a combination of the Pitkin Limestone, Fayetteville Shale, and Batesville Sandstone formations formed during various periods in the Mississippian. Limestone and chert tend to yield alkaline soils (pH >7), while sandstone and shale tend to yield slightly acidic soils (pH <7). Marine fossils, such as bryozoans, brachiopods, and crinoids, also tend to be present to varying degrees in these formations.

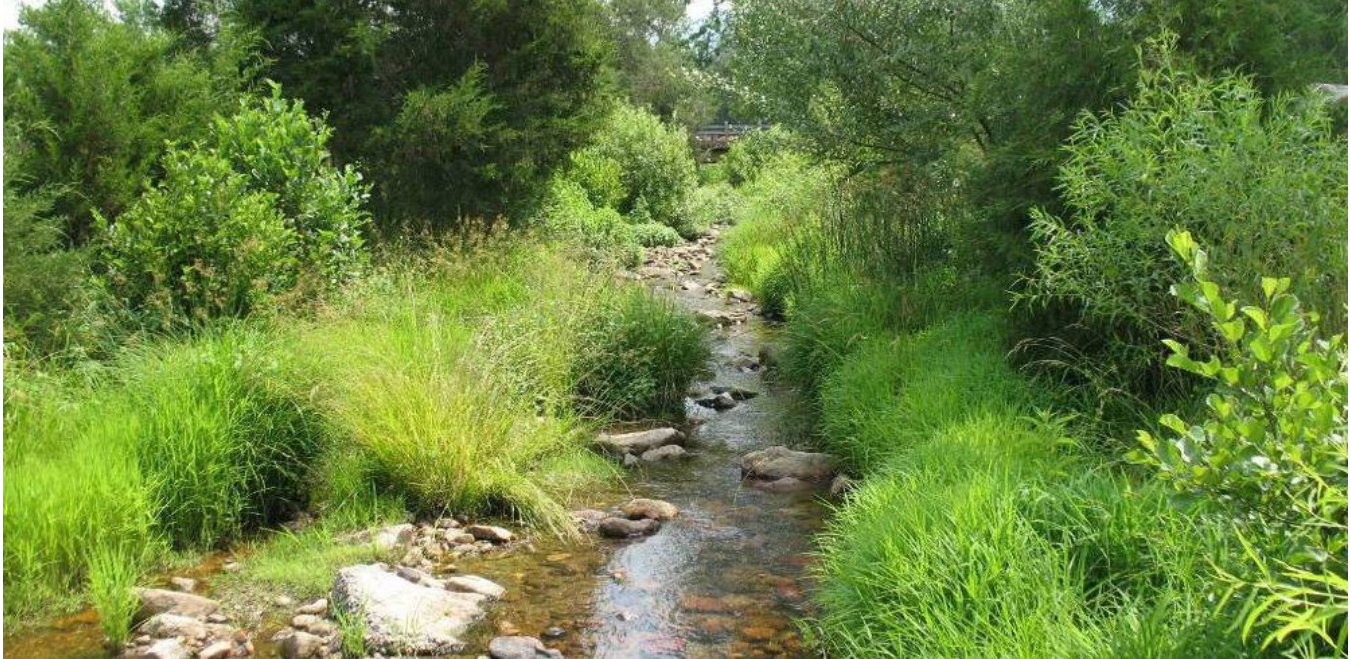
Figure 20: Healthy riparian areas should incorporate a diverse mix of water-loving grasses like rushes and sedges, forbs like bluestar and cardinal flower, aggressively rooting shrubs like Carolina willow, Chickasaw plum, Viburnum, ninebark, elderberry, spicebush, buttonbush, vernal witch-hazel, deciduous holly, American hazelnut, and shrubby St. John's wort underneath shade-producing trees like river birch, black willow, basswood, sycamore, Source: Mini-guide to Types of Riparian Buffers, James River Association.

Riparian areas with a “rough” look are perfectly fine and natural-looking (Fig. 20). Only species indigenous to the Ozarks should be incorporated in any planting, preferably local-ecotype species (plants with genetic stock originating from the Ozarks ecoregion). Buffer width should increase in response to environmental variables like slope, erodability, and traffic (Hawes, 2006) and should incorporate visible designated access lanes to points of interest inside the riparian area, such as the large pond and perennial streams. Clearly designated and visibly marked access points will discourage the creation of “rogue” trails, which can destabilize the riparian area, reduce visual appeal, and decrease the buffer’s effectiveness.

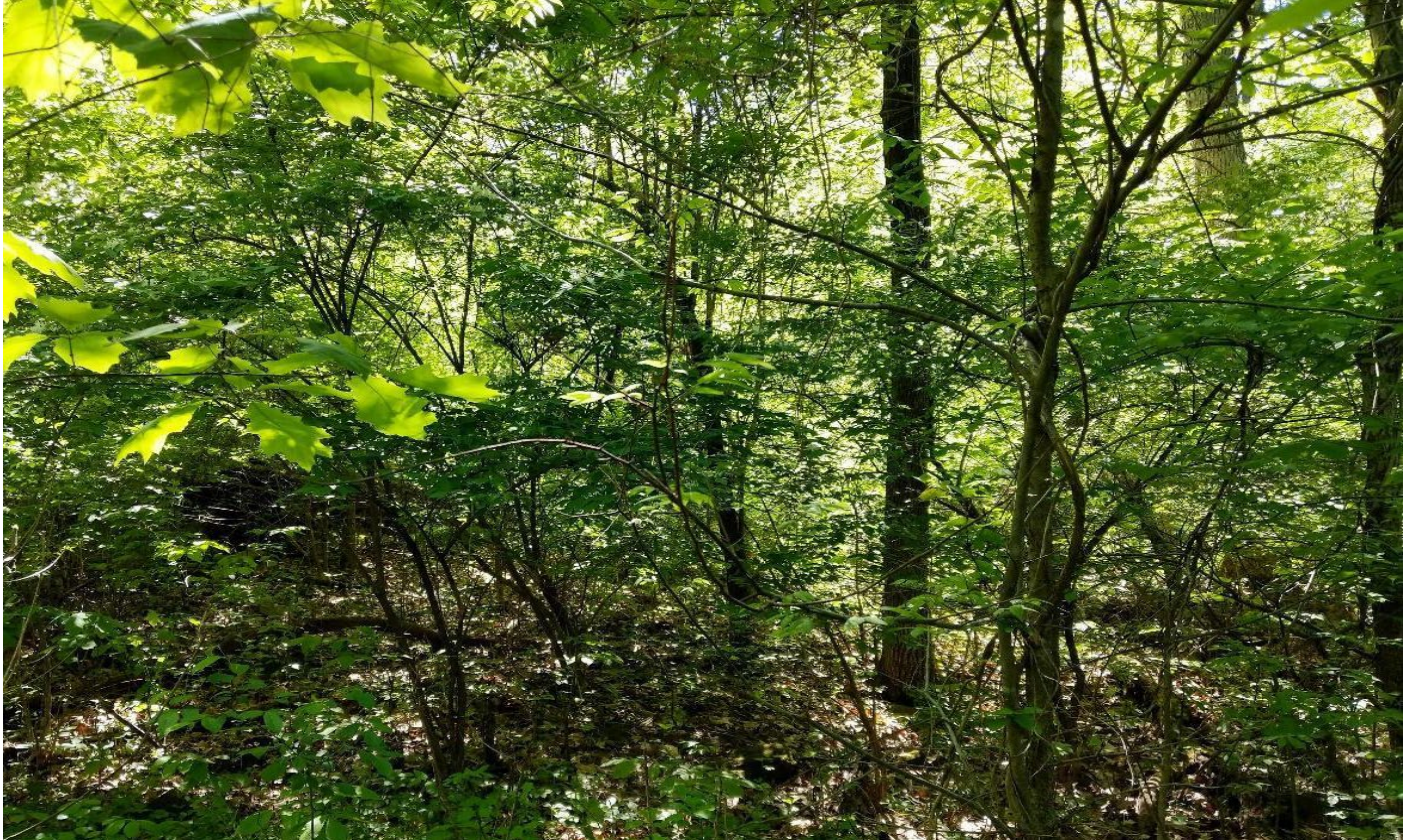
Figure 20: Canopy occlusion (seen here) prevents sunlight from reaching the forest floor, discouraging desirable grass and forb growth while encouraging vines, unhealthy tree growth, and invasive infestation.

The dense, brooding forests present in contemporary North American landscapes, particularly near urban centers (Fig. 20), took many decades to develop. The institution of fire suppression, fueled by the view of fire as a fundamental threat to development, has removed this unique and necessary regenerative feature from our landscape and has had the unforeseen consequence of promoting the proliferation of non-native invasive species in natural areas and expediting the decline of numerous plant and animal species. Although open forests and woodland were historically abundant, they have become exceedingly rare.

Excessively dense or “occluded” forest canopies prevent sunlight from reaching the forest floor, shifting the local environmental conditions to a state which no longer supports them while often supporting exotic invasive competitors. In heavily occluded forests, native grasses, forbs, and even saplings are completely shaded out as established plants or those requiring less sunlight dominate. Saplings futilely compete for limited sunlight, growing twisted, unhealthy, developing poor root systems, often becoming hollow if they do manage to reach maturity. These short, twisted, and sickly trees are susceptible to being overtaken by aggressive native vines like greenbrier and American bittersweet as well as invasive exotic species like Japanese honeysuckle, wintercreeper, and Asian bittersweet. These vines’ mass bend over and “lodge” already struggling seedlings under a brooding mound of vines. Maintaining healthy canopy density allows sunlight to reach the forest floor, encouraging native grasses, wildflowers, and saplings to mature and replace older trees as they die off. Maintaining a healthy canopy also increases airflow, reducing plants’ susceptibility to disease.

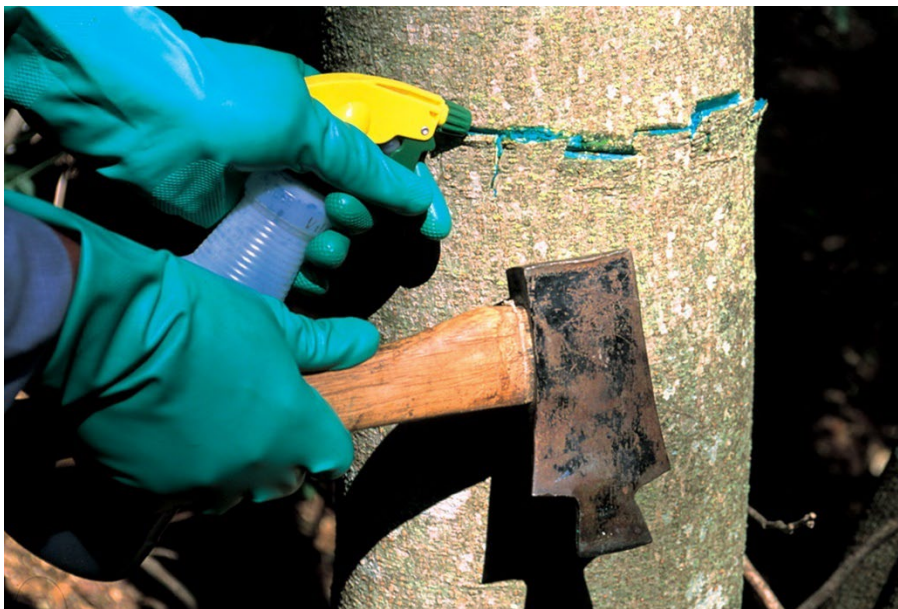
Figure 21: Example of "hack and squirt" canopy thinning technique. Several cuts are made into the cambium layer of a mature tree, usually with a hatchet. An herbicide is then applied into the cuts, often with a squirt bottle. Source: Woody Invasives of the Great Lakes Collaborative.

Performing an ecological thin or timber stand improvement can help increase the biodiversity and general vitality of a forest or woodland and is primarily meant to prioritize the removal of invasive woody species and reduce tree stand density to open the forest canopy, especially in preparation for long-term management with prescribed burns. Tree stand density, often measured in square feet of basal area per acre, can be determined by a forester. The thinning itself can be performed either commercially or non-commercially but should also be performed by a certified forester to prevent timber theft. A mature tree can be worth thousands of dollars, depending on the size, species, and quality of the tree. Timber stand improvement uses a technique called “hack and squirt” (Fig. 21) to remove trees of a diameter class, species, or a combination thereof to improve productivity, survivability, and recruitment of the desired species to increase diversity. A hatchet or machete is used to make several small cuts into the tree’s cambium layer, into which an herbicide is

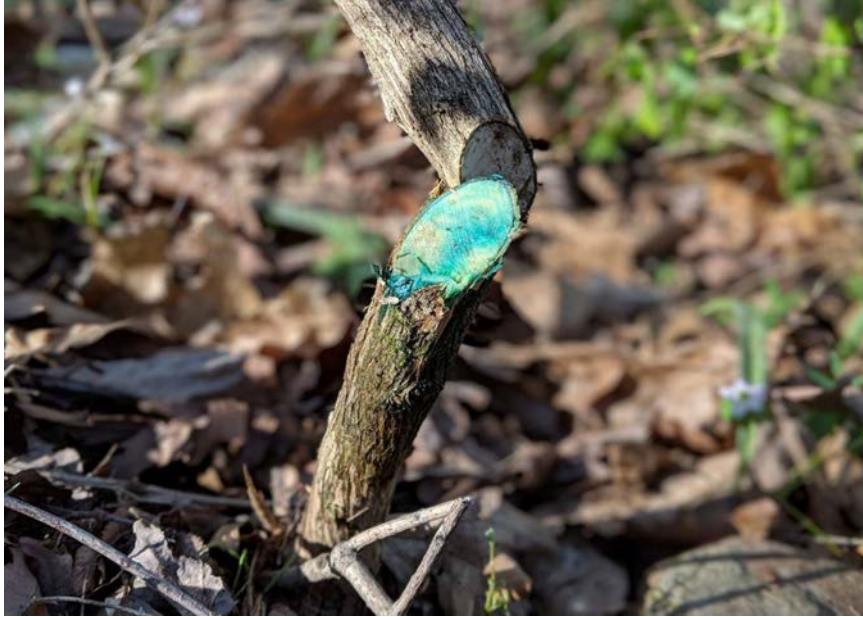
Figure 22: Bush Honeysuckle stump, treated with “cut and paint” technique. The blue is a marker dye to indicate successfully treated stumps. This method allows precise targeting of undesirable species and is recommended for understory shrubs. Photo by Nate Weston, Beaver Watershed Alliance.

injected. An alternative practice is “cut and paint” (Fig. 22), whereby smaller woody vegetation, often multi-stemmed shrubs, are cut low to the ground and the herbicide “painted” on the stump. This practice is preferable when numerous dead trees are a safety concern or would be unsightly, although this technique is more labor-intensive than “hack and squirt.” Both methods can be used to thin an excessively dense canopy or cull undesirable species, such as exotic invasives.

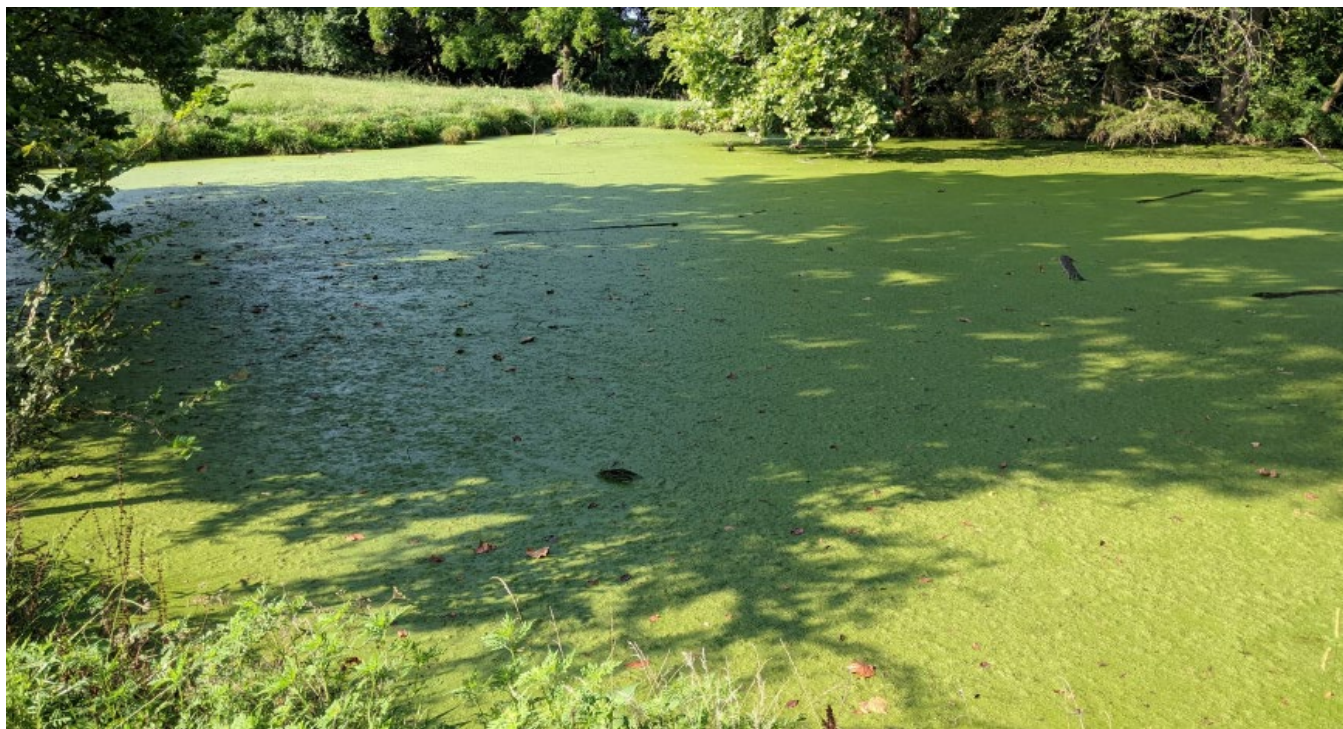
Figure 24: The small pond (#2), showing an abundance of aquatic vegetation due to nutrient loading. Photo by Erin Scott, 2021-07-29.

This zone is characterized by a small pond in the center, scattered hardwood trees, and a small ephemeral drainage bordering the south and west sections. The canopy here is a diverse mix of elms, oaks, walnut, hackberry, and mulberry with an understory dominated by pasture grasses. A very faint path leads south towards a gate in the southeast corner, connecting it to zone 6. A single purple milkweed (*Asclepias purpurascens*), the only one seen here, was discovered just east of the pond in this zone. The stream is densely vegetated with no apparent access. Since this appears to be a stream on the boundary with existing riparian vegetation, management activities might be prioritized elsewhere on the property. The pond has a relatively small drainage area but due to livestock access is highly eutrophic and often entirely covered in aquatic plants (primarily duckweed and watermeal), algae, or both during the growing season.

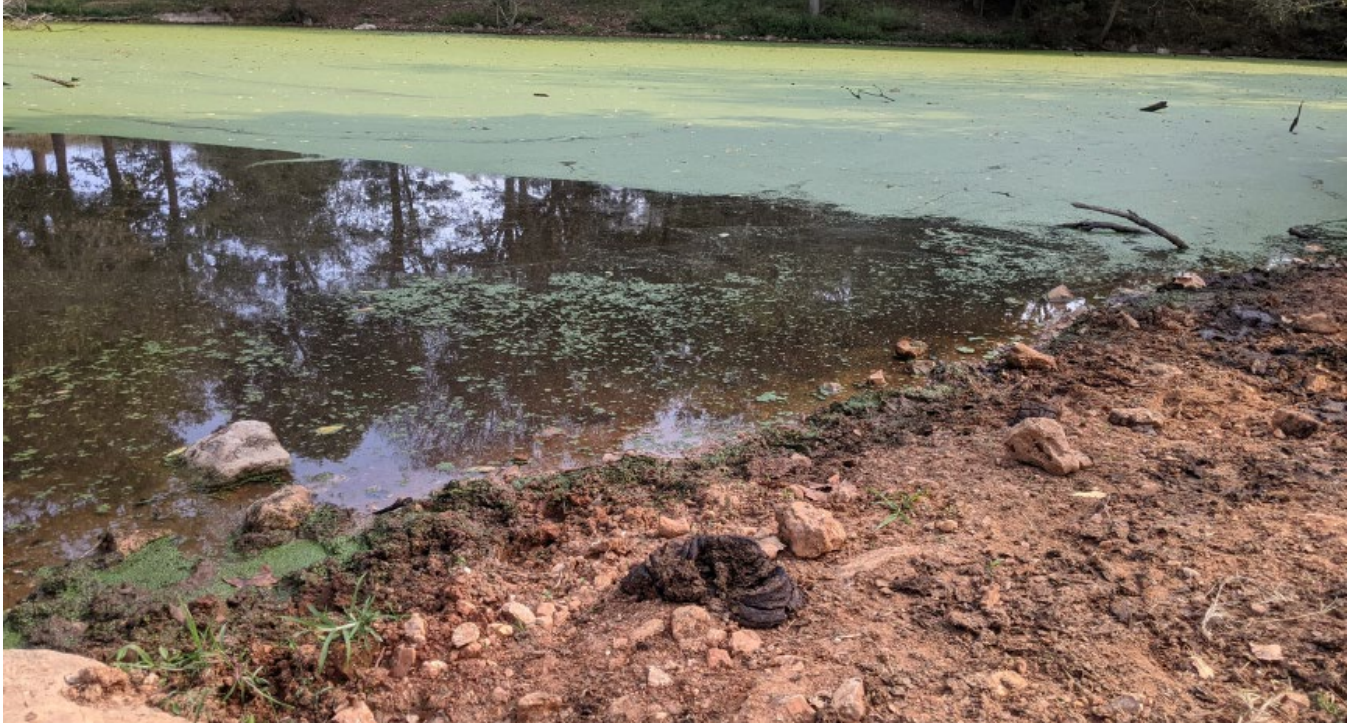
Figure 25: Prolific duckweed seen on pond #2 due to excess loading of nutrients from livestock. Note the pile of cattle manure (foreground). Photo by Erin Scott, 2021-09-12.

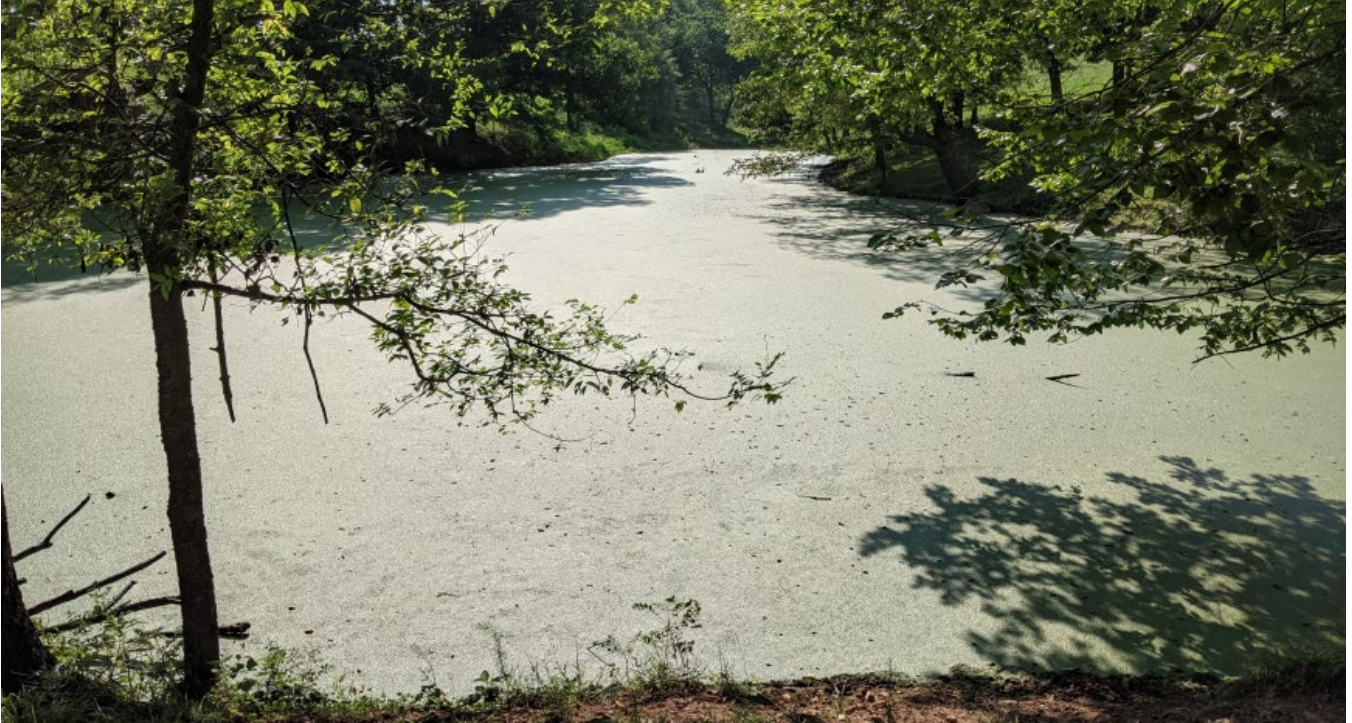
Figure 26: The large pond (#1) as seen from the earthen dam, facing east. Photo by Erin Scott, 2021-07-29.

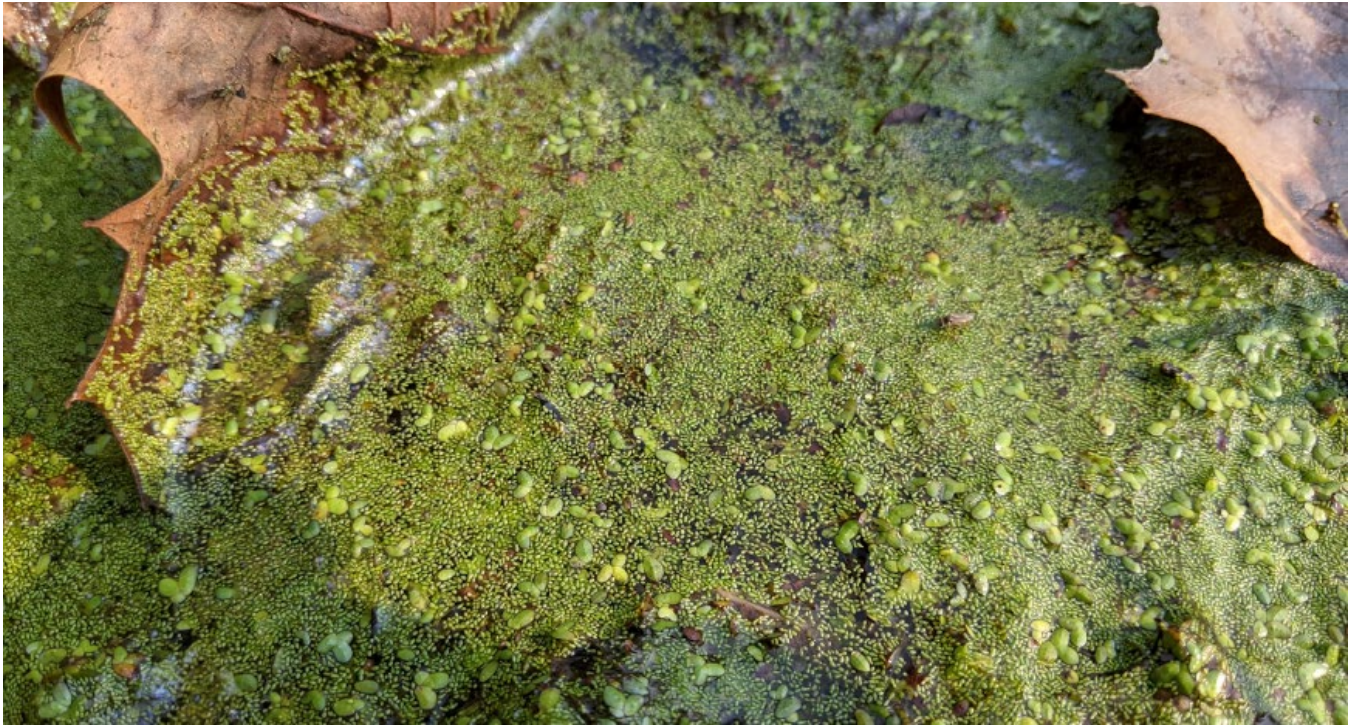
Figure 27: Blanket of duckweed and watermeal in the large pond (#1). Photo by Erin Scott, 2021-09-12.
